NASA  
Spaceport Engineering and Technology Directorate  
Labs and Testbeds Division  
Kennedy Space Center, Florida  
September 17, 2001

KSC-MSL-0488-2001

SUBJECT: Failure Analysis of a Fuel Cell Power Reactant Supply and  
Distribution (PRSD) Liquid Hydrogen (LH<sub>2</sub>) Relief Valve P/N  
K5120T-3MP-285

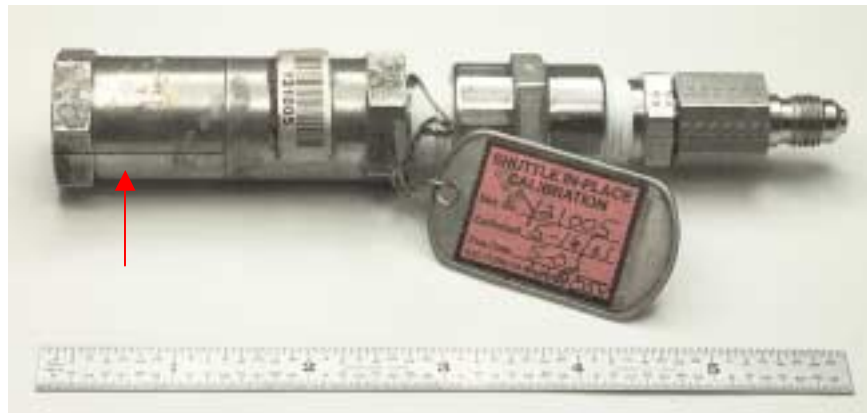
Figure 1

- 3.1 The valve is shown as-received in Figure 1. A longitudinal crack was evident in the valve body (Figure 2).
- 3.2 Macroscopic examination of the valve body revealed the presence of corrosion products on the fracture surface (Figure 3). The fracture surface appeared "woody," typical of SCC.
- 3.3 Examination of the fractures via scanning electron microscope (SEM) revealed "mud cracking" of corrosion products, as well as transgranular fracture features (Figure 4), both typical of SCC. A laboratory-induced overload exemplar (Figure 5) exhibited ductile fracture features;

As-Received valve. Arrow indicates crack.

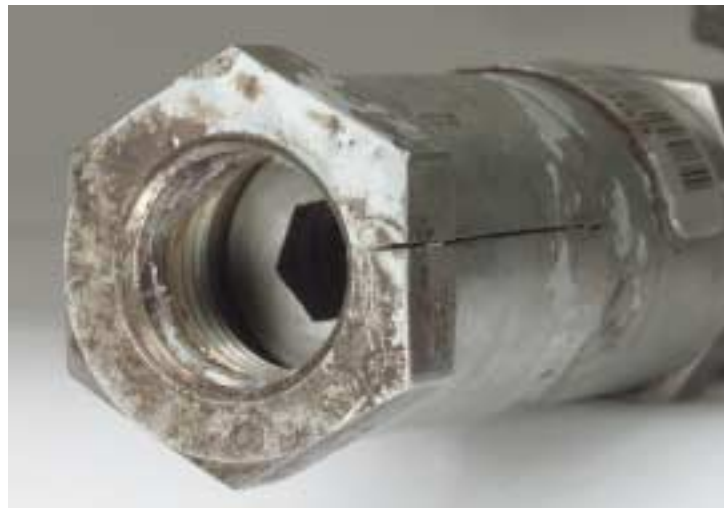
Figure 2

As-Received valve body. Magnification: 3X

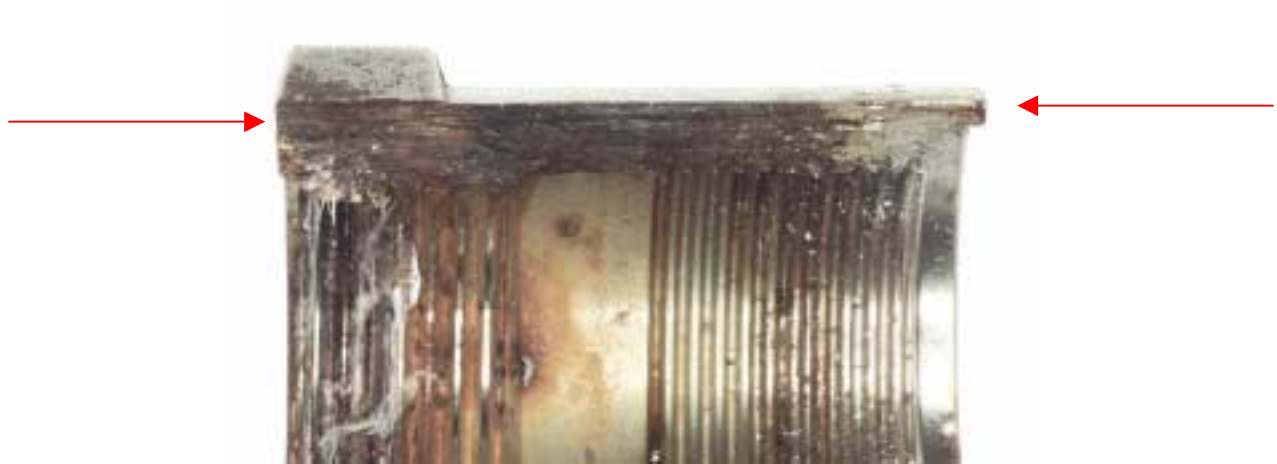
Figure 3

Macrographic view of the fracture surface from the valve. Note the “woody” appearance of the fracture surface (between the arrows) and the presence of corrosion products. Magnification: 5X

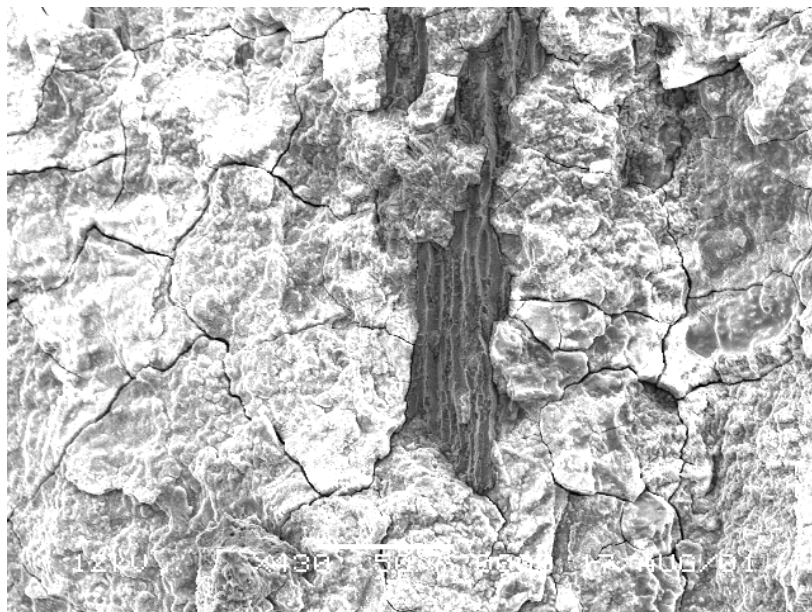
Figure 4

SEM micrograph of “mud cracking” of corrosion products surrounding a portion of the fracture surface. Magnification: 430X

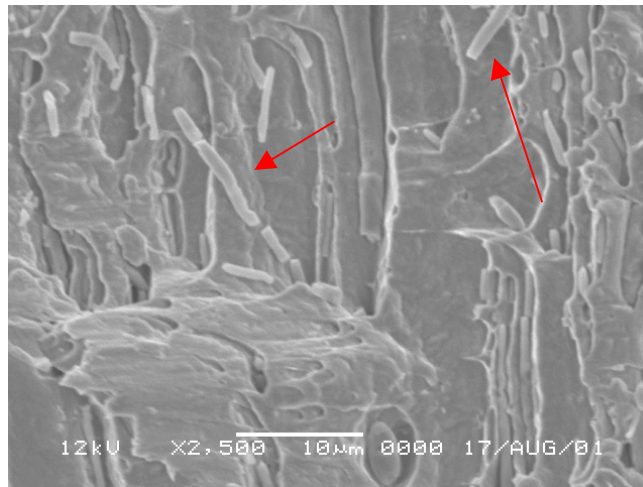
manganese-sulfide stringers (verified via energy dispersive X-Ray spectroscopy [EDX/S]) were also observed. EDX/S analysis also revealed the presence of chlorides on the fracture surface.

Figure 5  
SEM micrograph of laboratory-induced overload exemplar, showing stringers (indicated with arrows). Magnification: 2,500X

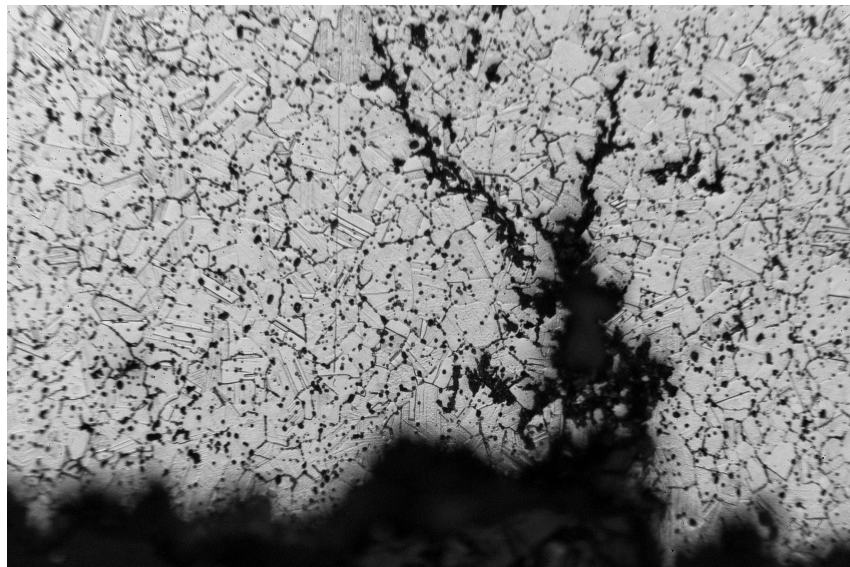
- 3.4 Chemical analysis via inductively coupled argon plasma and combustion techniques indicated that the valve body had a composition similar to that of 303 austenitic stainless steel.
- 3.5 Metallographic examination of the valve revealed secondary cracking emanating from the primary transgranular crack (Figure 6). Stringers were evident throughout the sample, with some exposed to the surface. Converted microhardness measurements averaged approximately 23 Rockwell C scale.

The valve was composed of 303 stainless steel and failed due to SCC. Three factors are required for SCC to occur: a corrosive environment, a source of sustained tensile stress, and a susceptible material. The environment at KSC is highly corrosive to many materials, satisfying the first criterion for SCC. The stresses developed during service, as well as residual stresses from manufacture, would satisfy the second requirement for SCC. 303 austenitic stainless steel is considered to have low resistance to SCC (per MSFC-STD-3029), meeting the third prerequisite for SCC.

Figure 6  
Micrograph of a cross-section of the valve body displaying secondary crack branching. Etchant: 10% Oxalic Acid (electrolytic). Magnification: 150X

The use of 303 stainless steel is not recommended at KSC. Alternate materials, such as those listed in Table 1 of MSF-STD-3029, could provide better resistance to SCC.
